CONCRETE CANVAS® EROSION CONTROL

Case Study

Project Name	Austin Bluffs & Meadow Ridge Stairs Repair
Location	Colorado Springs, Colorado
Date of Installation	August 2023
Contractor Owner	Timberline Building Systems City of Colorado Springs
Salesperson	Ryan Anderson
Application/Solutions	Concrete Canvas® used to provide erosion control to eroding slope.

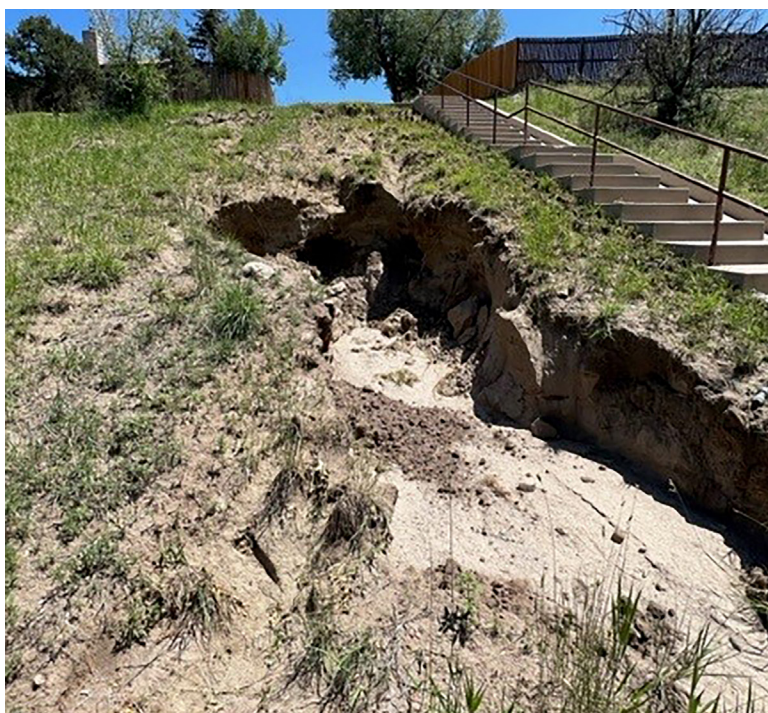
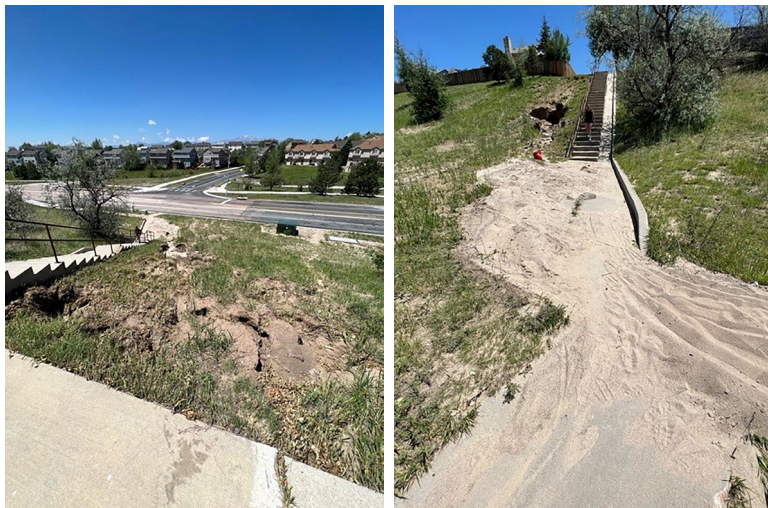
There was a severe erosion problem on a slope along a set of stairs in this Colorado Springs neighborhood. Water coming off the sidewalk eroded the slope and left a mess of sediment all over the sidewalk.

Pictures of the erosion problem before Concrete Canvas® installation.

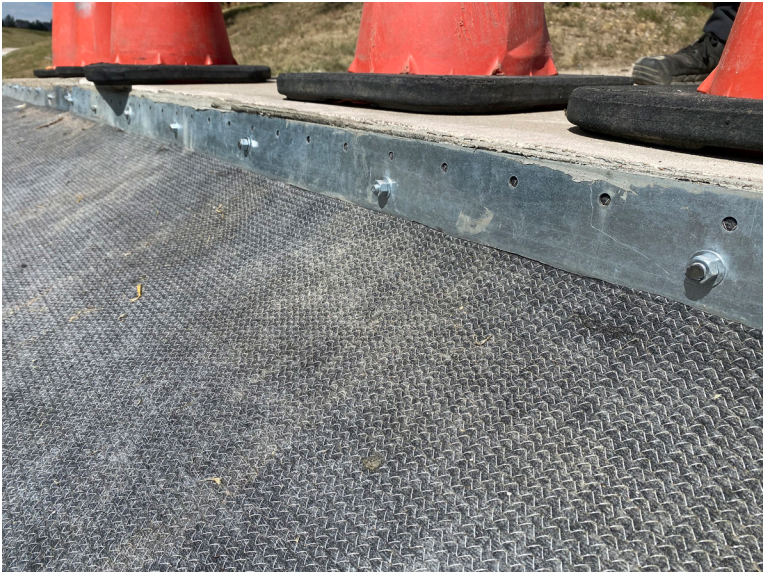
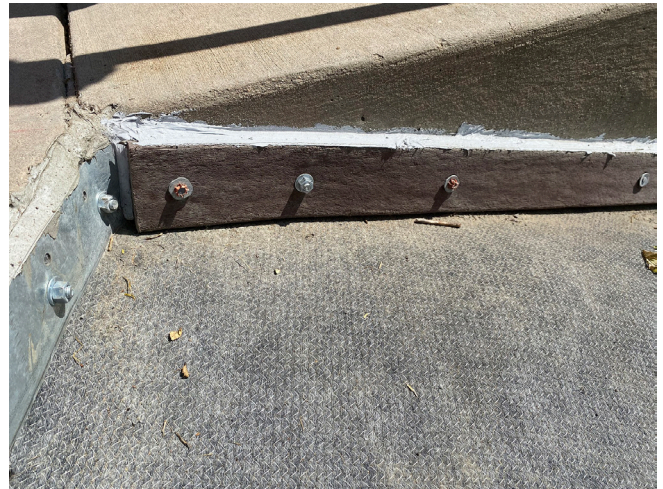
Concrete Canvas® Attached to Concrete with Stainless Steel Clamping Bar and Through-Bolts, a Gasket & a Grout Filler

The material was then secured within anchor trenches using anchor pegs and later backfilled with excavated substrate. The CC installed along the concrete sidewalk and stairs was attached to the concrete using a stainless steel clamping bar and through-bolts, a gasket, and a grout filler to prevent water ingress.

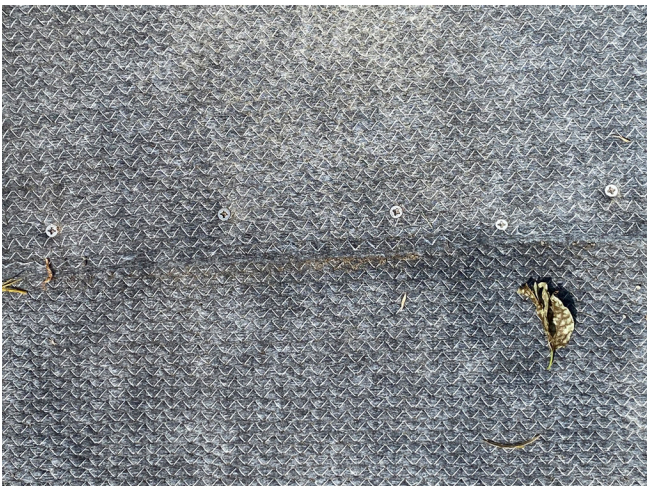
Overlapped CC Layers Secured Using Stainless Steel Screws

Each layer was overlapped by 4" in the directional flow of water. Stainless steel screws set at 4" spacings and 2" away from the overlapping edge were used to secure the CC material down.

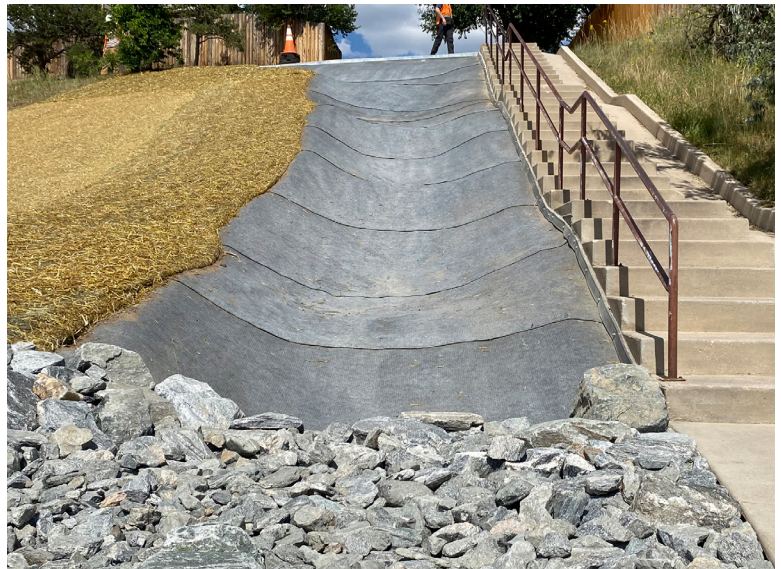
Concrete Canvas® Laid Transversely Across the Slope & Rolling Berms

After the slope was regraded, rolling berms were added to slow the flow of water coming from the sidewalk. Next, batched rolls of Concrete Canvas® were brought on-site and laid by hand transversely across the slope and the berms.

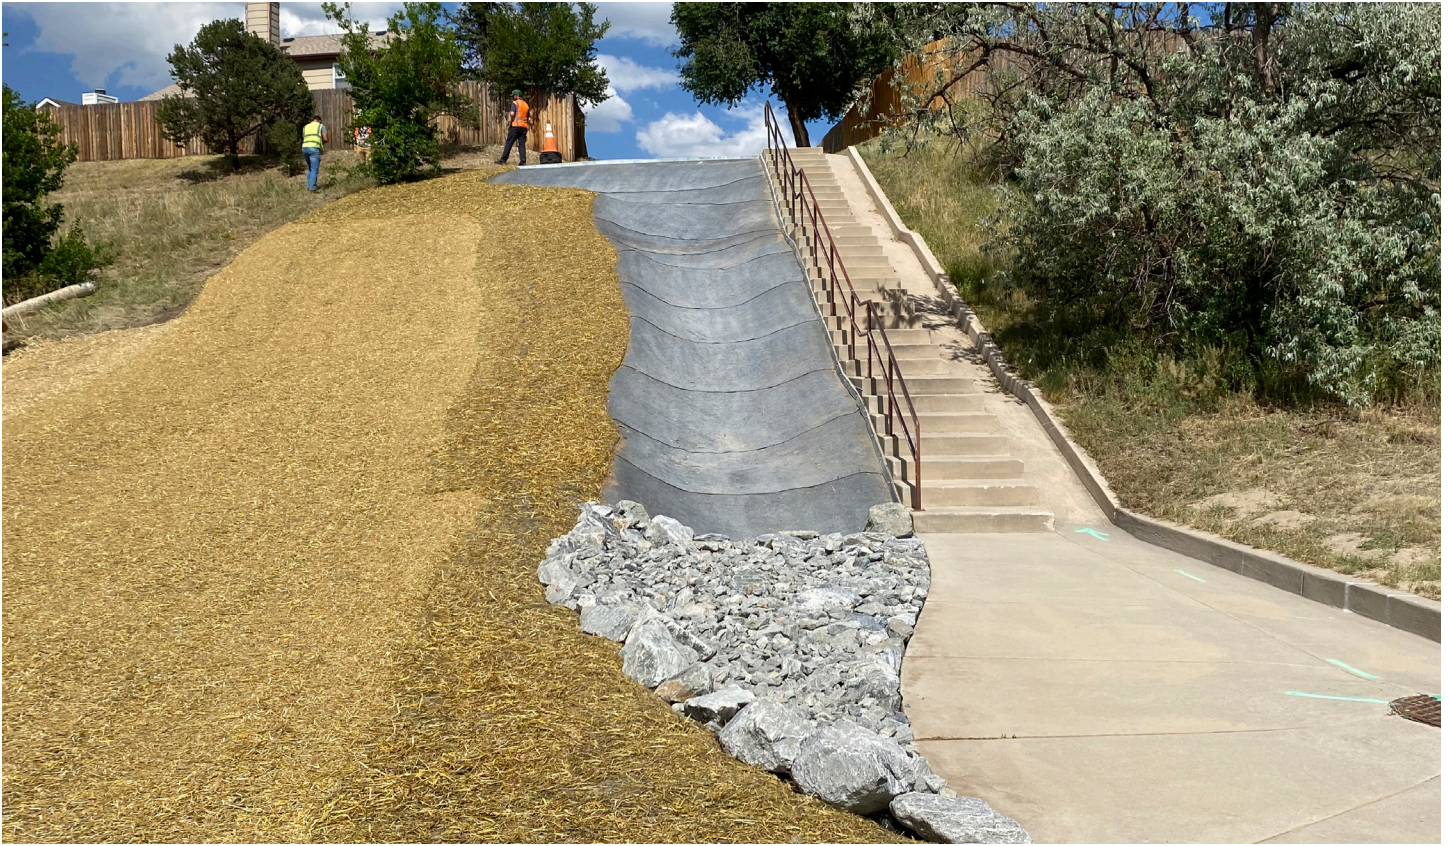
Completed Installation

The Concrete Canvas® manages water runoff from the sidewalk and creates a channel for the water to flow down, preventing slope erosion. The installation was completed very quickly in just four days. It took two days of grading to create a solid and uniform surface and then two days to complete the Concrete Canvas® installation.
