Water-filled Barrier Walls for Stormwater and Sediment Control on Steep Slopes

Chase Hemming, P.E.,¹ and Josef Tootle, P.E.²

ABSTRACT

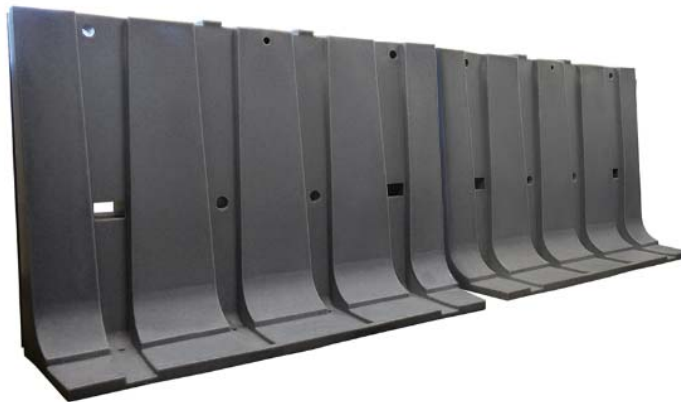
A low density polyethylene (LDPE) barrier wall product called "Muscle Wall" was evaluated for its use in stormwater and sediment control on steep slopes. The barrier walls are approximately 4 feet in height, 6 feet in length, 2.5 feet in base width, 0.7 feet in top width, and 120 pounds in weight. The barrier walls are interlocked, secured to each other using ratchet tie down straps, filled with water, and wrapped with a plastic or geotextile liner to produce a linear barrier system. An image of two interlocked barrier walls without ratchet tie down straps or liner is shown in Figure 1.

Figure 1. Two interlocked barrier walls.

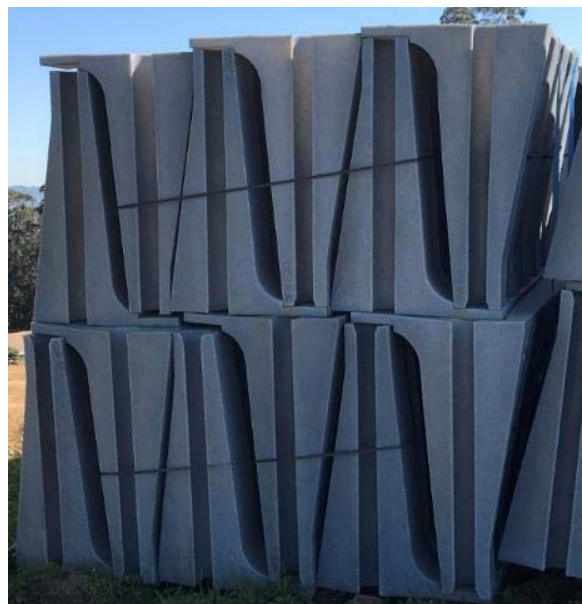
Approximately 4,000 linear feet (LF) of the barrier wall product was ordered for the project site. The barrier walls, plastic liner, ratchet tie-down straps, and liner clips were shipped to the project site on seven truck trailers (approximately 95 barrier walls per truck trailer). Each pallet of the barrier wall product was observed to take up an approximately 8 feet by 6 feet footprint, and contained 12 barrier wall segments as shown in Figure 2. The barrier wall product pallets were removed from the truck trailer using a forklift and stored on the project site prior to deployment.

Figure 2. Stacked barrier walls.

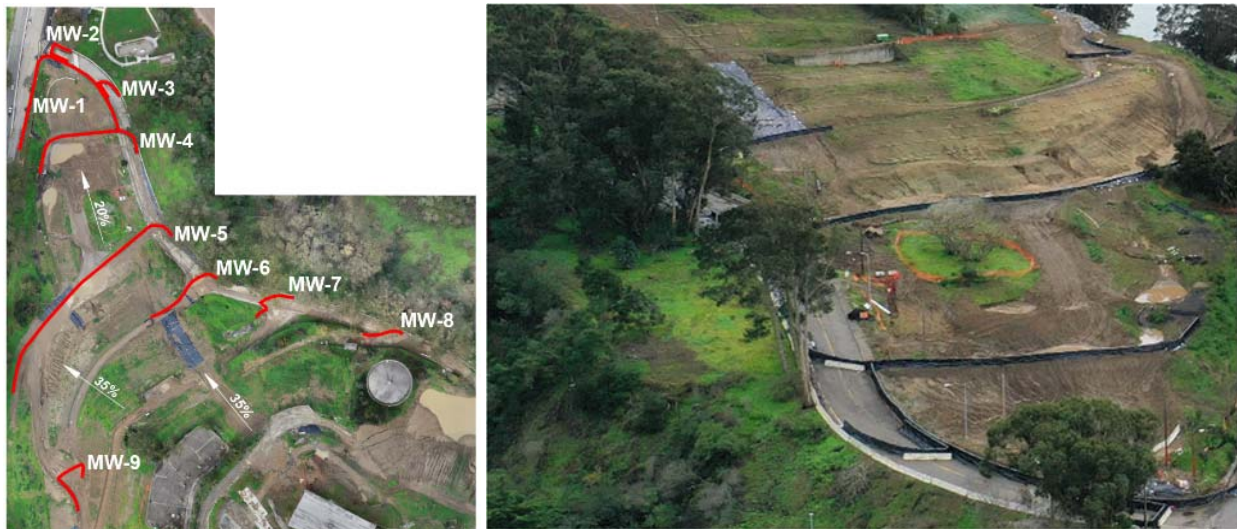
The basins were designed to detain the runoff volume produced by a rainfall depth of 2 inches (approximately equal to that of a 10-year-recurrence-interval, 6-hour-duration storm). For storms forecasted to produce greater than 2 inches of rainfall, water trucks were staged at one of the downslope basins so that collected stormwater could be pumped and transported to a high capacity infiltration-evaporation basin in a flat region of the site. While expensive, the cost of the pumping and trucking operation was deemed cheaper than the cost of not completing the mass grading work on time. A series of nine temporary barrier wall basins with an average spacing of 150 feet were placed along the hillside, as shown in Figure 3.

Figure 3. Aerial view (left) and side view (right) of the barrier wall basin locations.

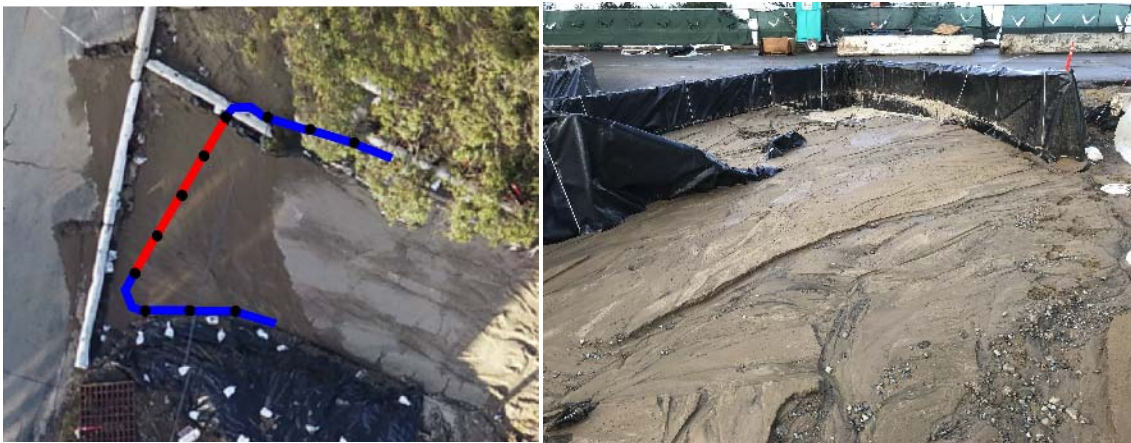
Basin MW-2 was located at the bottom of an asphalt concrete haul road with a cross slope of approximately 10 percent. The initial configuration (Figure 4, left) was composed of four unfilled barrier walls (red) anchored by three water-filled barrier walls (blue) on each end. Two 90-degree corner walls were used to assist in forming the basin. After the first storm, the entire basin slid (but did not overturn) due to sediment impact and buildup (Figure 4, right). After this storm, two additional water-filled barrier walls were added on each end of the basin (Figure 5, left). Following this addition, Basin MW-2 did not slide during subsequent storm events (Figure 5, right).

Figure 4. MW-2 initial configuration (left) and performance after first storm (right).

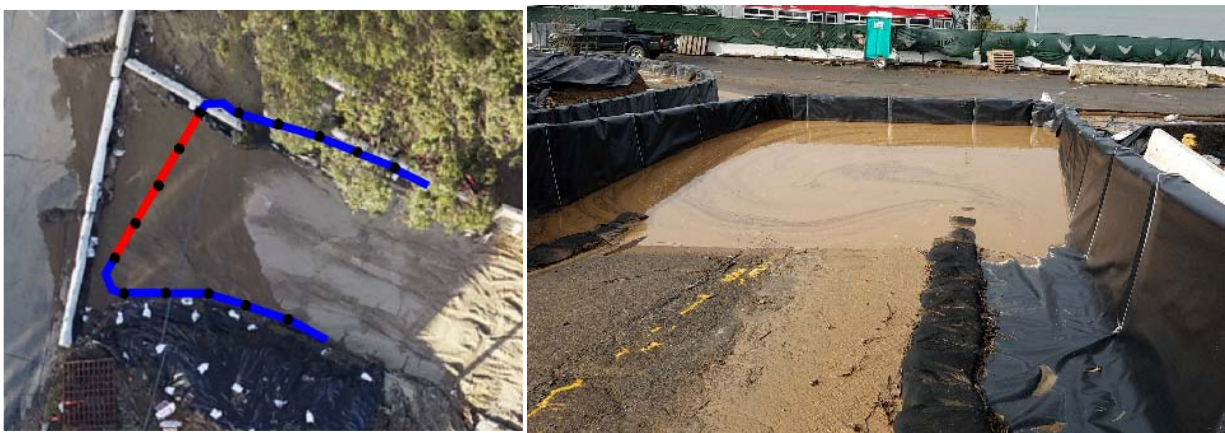
Figure 5. MW-2 revised configuration (left) and performance after subsequent storms (right).

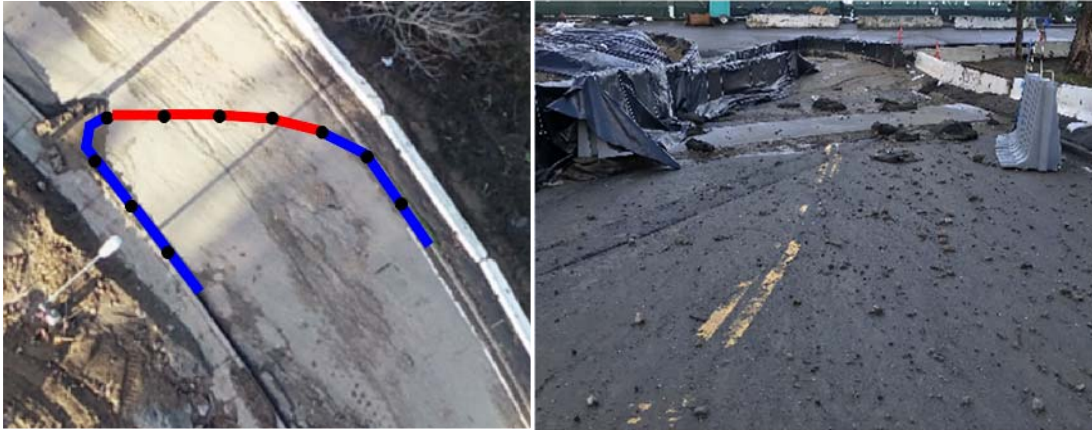
Basin MW-3 was located across an asphalt concrete haul road with a cross slope of approximately 18 percent. The initial configuration (Figure 6, left) was composed of four unfilled barrier walls (red) anchored by three water-filled barrier walls (blue) on each end. One 90-degree corner wall was used to assist in forming the basin. After the first storm, the basin slid and multiple barrier walls disconnected from each other due to sediment impact and buildup (Figure 6, right). After this storm, three additional water-filled barrier walls were added on each end of the basin (Figure 7, left). Following this addition, Basin MW-3 remained stable during subsequent storm events (Figure 7, right).

Figure 6. MW-3 initial configuration (left) and performance after first storm (right).

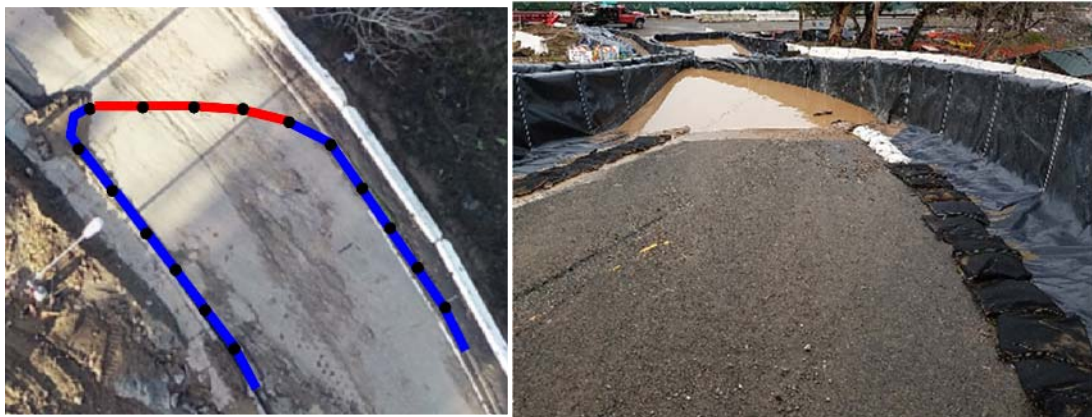
Figure 7. MW-3 revised configuration (left) and performance after subsequent storms (right).

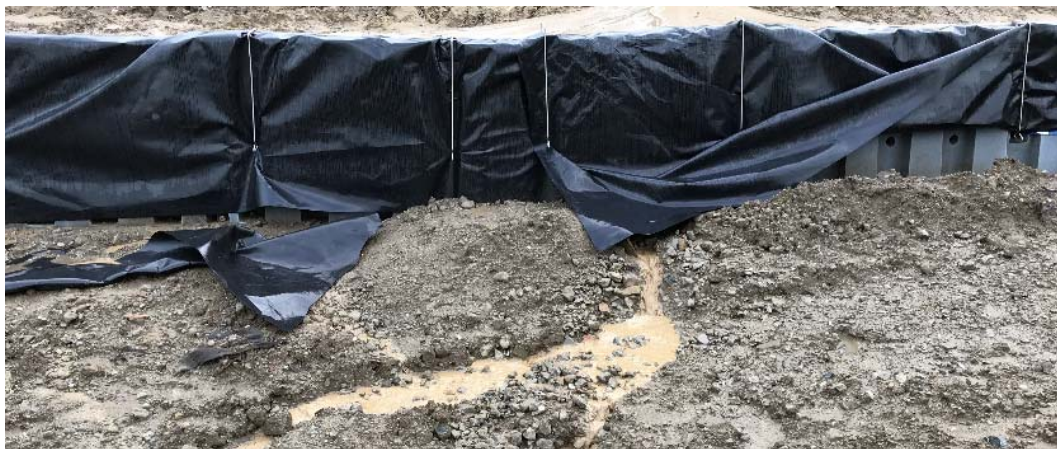
Basin MW-5 was placed on fairly level compacted soil with all barrier walls filled with water. Basin MW-5 was effective at slowing stormwater runoff and trapping entrained sediment; once volumetric capacity was reached during a rain event, stormwater would both overtop and seep under the barrier walls down gradient to Basin MW-4 (Figure 9). Stormwater was able to seep under the barrier walls of MW-5 since the plastic liner did not continue along the interior of the basin like Basin MW-4. In addition, irregularities in the ground surface created small gaps for water to flow through. The turbidity of water leaving the basin appeared similar to that of water entering the basin. Basin MW-5 did not experience any lapses in stability, even when overtopped by stormwater and impacted by sediment buildup.

Figure 9. Seepage under the barrier wall.

To reduce seepage under the barrier walls, the plastic or geotextile liner could be trenched into the ground on the water side of the barrier wall (if placed on soil). For barrier walls placed on pavement, seepage under the barrier walls could be mitigated by placing sand bags tightly along the toe of the barrier walls. To reduce uncontrolled overtopping, the barrier wall product manufacturer developed a double-orifice discharge port during the end of the study period. A hose could be connected to the discharge port to route stormwater to an active treatment system or other water quality BMP to help reduce stormwater turbidity before offsite discharge. A rendering of the discharge port (left) and photo of the manufactured discharge port at the project site (right) are shown in Figure 13. The discharge port was not tested during the study period.

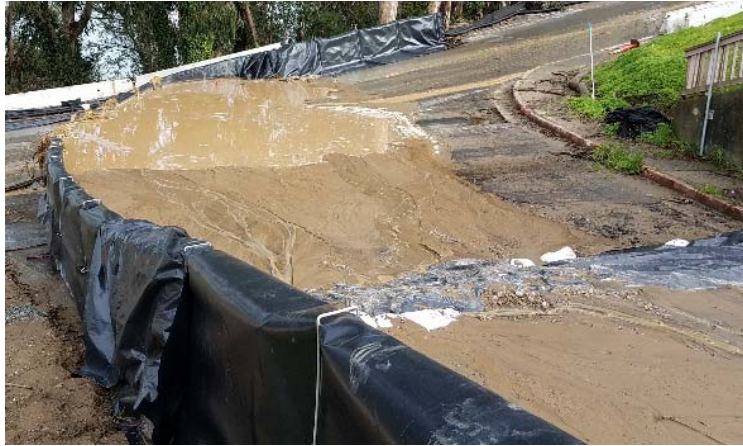
were not filled with water. Like Basin MW-5, Basin MW-6 did not experience any lapses in stability while at capacity with stormwater and entrained sediment (Figure 10). Stormwater was observed to seep under the barrier walls during storm events; the turbidity of water leaving the basin appeared similar to that of water entering the basin.

Figure 10. Basin MW-6 retaining 4 feet of sediment following a storm.

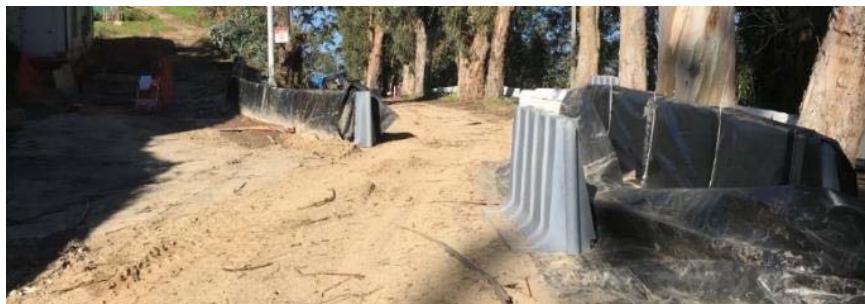
Basin MW-8 was located across a compacted soil haul road with a cross slope of approximately five percent. Like the other basins located across haul roads, five middle barrier walls were not filled with water. Figure 11 below depicts the empty barrier walls set aside during dry weather so that the haul road could be used. Because Basin MW-8 was the furthest upslope basin, it collected the least amount of stormwater runoff and never filled to capacity. However, it succeeded as a check dam for slowing water flow and detaining entrained sediment.

Figure 11: Empty barrier walls set aside for haul road use.

Leaving some barrier walls unfilled when located across an active haul road was convenient for the contractor’s site access; during non-storm conditions, the contractor would disconnect the unfilled barrier walls from the basin and set them aside to allow haul road use. If a storm event was forecasted, the contractor was able to quickly reconnect the unfilled barrier walls across the haul road.

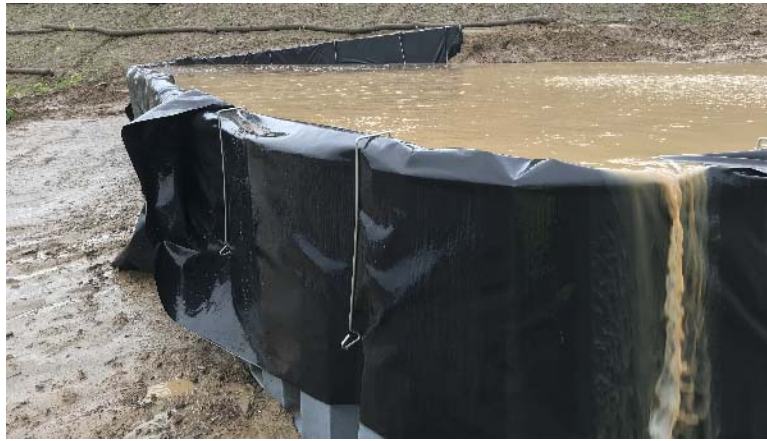
Basin MW-9 was located across a compacted soil haul road with a cross slope of approximately 10 percent. Five barrier walls in the middle of the basin were not filled with water, and the basin utilized two corner walls to assist in forming the basin. Basin MW-9 often filled to capacity with water during storms, and accumulated sediment throughout the study period (Figure 12). Over the duration of the study period, Basin MW-9 did not experience any lapses in stability while at capacity with water and sediment. The turbidity of water leaving the basin through overtopping and seepage appeared similar to that of water entering the basin.

Figure 12: Basin MW-9 overtopping during a storm event.
