CONCRETE CANVAS® DRAINAGE DITCH

Case Study

Project Name | CDOT I-25 South Gap Side Embankment Drainage

Location | Larkspur, Colorado

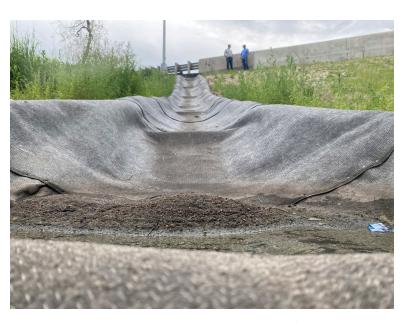
Completed Concrete Canvas® Installation

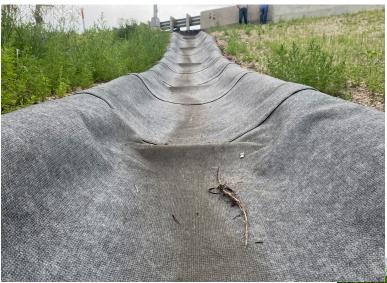
Overlapped CC Layers Secured Using Stainless Steel Screws

Pre-cut panels of CCX-MTM were brought on-site and laid by hand transversely across the ditch and the installed check dams. The material was then secured through perimetral anchor trenches using anchor pegs and later backfilled with excavated substrate. Each layer was overlapped by 4" in the directional flow of water. Stainless steel screws set at 4" spacings and 2" away from the overlapping edge were used to secure the CC material down. A sealant was used between layers, providing waterproof protection. After securing the Concrete Canvas[®] material, it was hydrated using a small, portable water tank and hose.

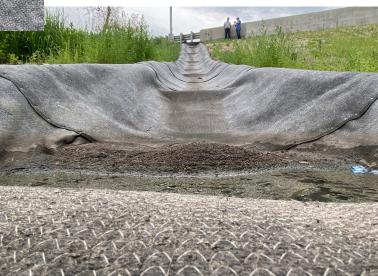
Check Dams & Dissipation Pond Covered in Concrete Canvas®

Prior to the Concrete Canvas® installation, vegetation and protrusions were removed, and the channel was regraded to create a solid and uniform surface. Anchor trenches were also excavated at the crests of the drainage ditch. To slow the flow of water coming from the highway, 4" diameter plastic pipes were placed underneath and lined with the canvas every 12' to create check dams, and a small dissipation pond was installed at the end of the drainage ditch to control the final water velocity.

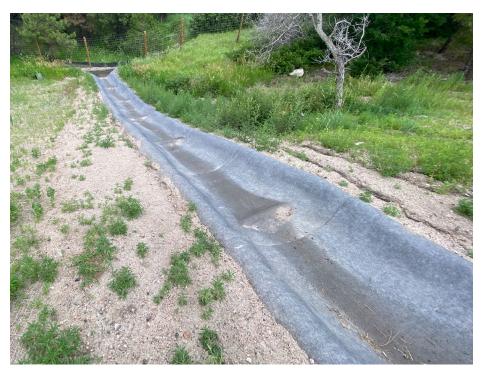
Completed Concrete Canvas® Installation

A total of 650ft² of Concrete Canvas® was installed, creating a 90' long x 7' wide x 1' deep drainage ditch. The CC installation took less than two days with a six-person team, and the overall project was completed in less than four days. The owner and contractor were impressed with both the speed and ease with which CC was installed and were very satisfied with the final results of the project.
